ASC-TR-96-1002

**ELEVATING AIRCRAFT RESCUE PLATFORM (Phase I)
PRODUCT EVALUATION REPORT**

12 February 1996

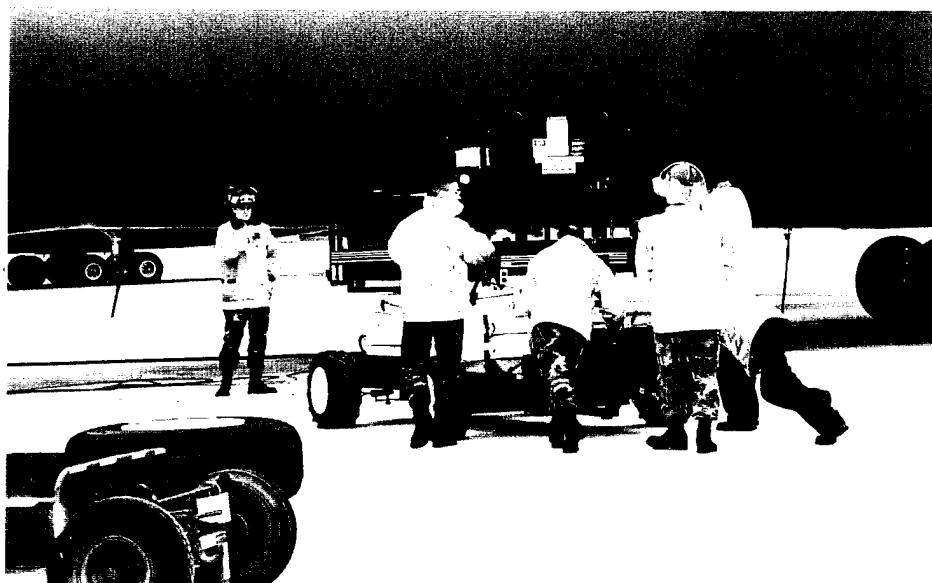
(2). The time required to position the system varies depending upon how much equipment or spilled fuel might be in the vicinity, but would nominally require a couple of minutes. To manually position the 3,500 lb. platform near the aircraft required 6 firefighters, one third of the normal fire/rescue response contingency. The awkward body postures and movements by the personnel positioning the platform could lead to lower back injuries or strains.

Manual maneuvering
Lift-A-Loft into position
